SMARTRAWL Phase 6- technical summary

FIS046

Smartrawl Phase 6 Report

March 2025

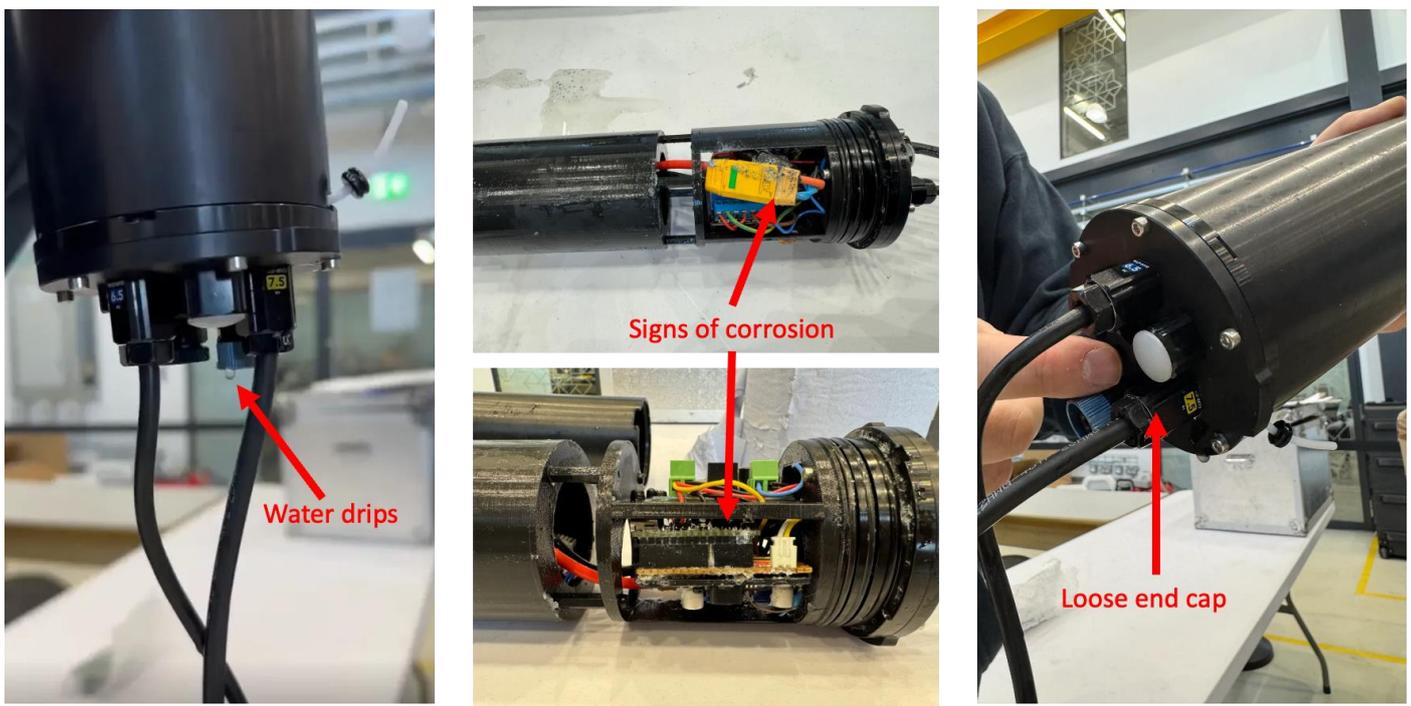
Figure 1: Latch bottle internals on inspection

On removing the latch bottle from the Pelican case in which it was transported back from Shetland, the latch bottle was found to be filled with water. Water couple be observed dripping from the top of the bottle when it was turned upside down. It was estimate about 50ml of water exited the housing. Whe the housing was opened it was discovered that all internal components were wet and signs of corrosion were visible. The corrosion or oxidisation of components can be caused by the electrochemical reaction with the salt and minerals in sea water. The battery was found to be still connected upon arrival and although it was soaked, it was still measuring at 15.5V.

A thorough inspection of the housing revealed that the centre blanking plug was found to be very loose, allowing for water ingress. The most likely situation was that this cap was only hand tight on leaving gthe workshop and loosed off in deployment. This is further supported by the Time vs Power Metric data recorded in Haul 4 which is detailed in section 4.3.

Detail inspection of the internal components confirmed that the majority were severely corroded and required replacement. The battery was also determined to be unsafe for furhter use and was correctly disposed of.

1. The latch electronics required a complete refurbishment with all the damaged components being replaced at the expense of the National Robotarium.

- The blanking cap should not have left the workshop being hand tight only. This is a failure of process. The fix is to improve the Quality Control checks ensuring all seals are fitted and all fasteners are correctly torqued up.

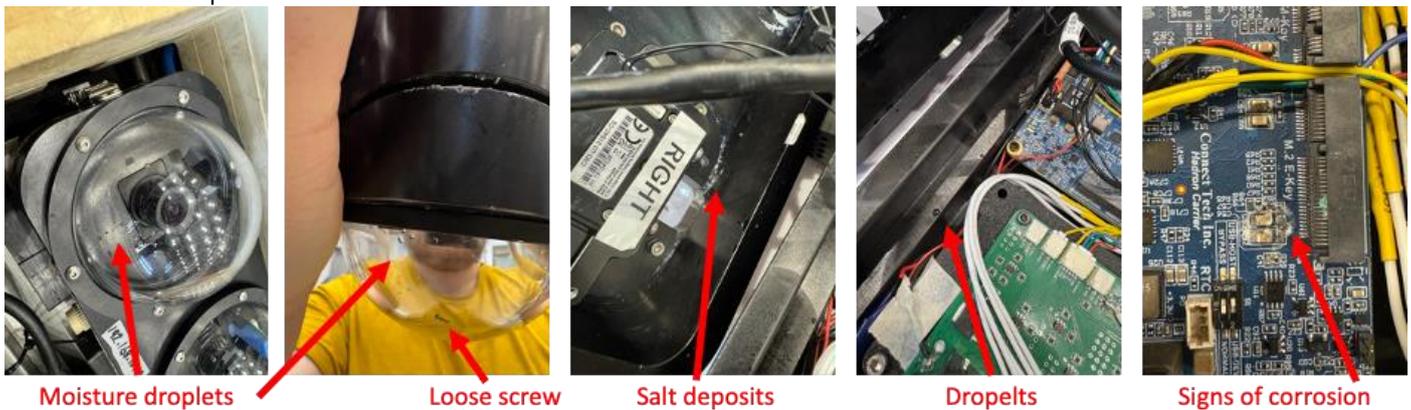
Figure 2 Camera housing internals

When the camera housing was inspected moisture droplets were found on the camera dome housing. On opening the housing it was noted that water droplets had dripped down on electronics causing shorts. A few of the components directly under the dome were found to be corroded. This explained the erratic behaviour of the system in later deployments. A loose screw from the IMU board was also found inside the housing. Two possible sources for water ingress were identified. Possibility one was an additional penetration for a pressure test port had been made in the housing, this could have leaked. Again this was found to be finger tight. Possibility two was that the dome seal on the dome with moisture droplets were found could have failed. This was more likely given that the water ingress volume was low and the effect of the leak was quite well localised to below the dome.

- The carrier board needed refurbished and fully tested.
- The Jetson board was also tested and found to be fully functional.
- The loose screw was refitted, and all internal fasteners were thread locked into place.
- The Pressure Relief Valve that was found to be hand tight was replaced.
- An extended vacuum test was done to validate dome seal, this failed.
- The dome was removed and inspected.

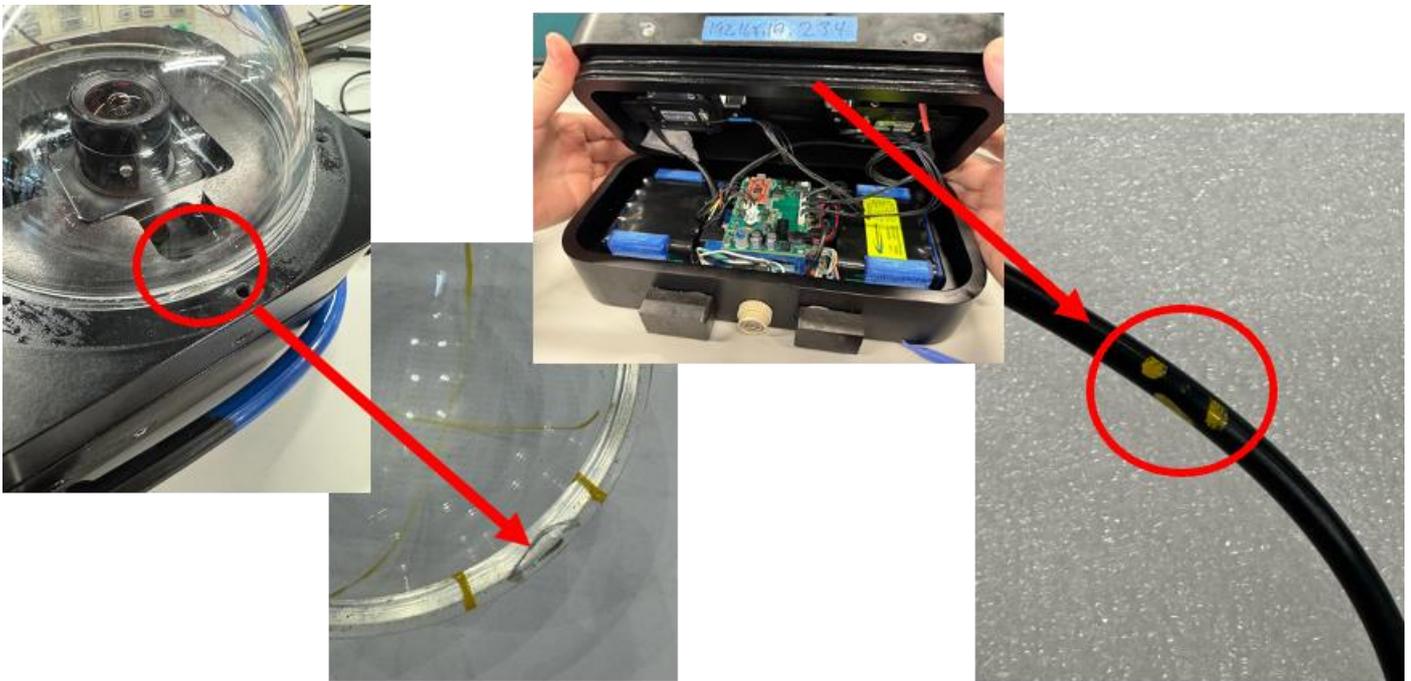
Figure 3 Camera dome and housing radial seal inspection

On close inspection of the dome two issues were found. Issue one was a chip in the seal groove. This would allow the seal to extrude slightly under pressure and was the source of the moisture on the dome. The lip seal on the housing was also found to have been pinched.

Chip in camera dome seal groove

Camera housing seal pinch

1. The damaged dome was replaced with a spare from stock.
2. It was reinstalled with a new seal.
3. The lip seal was also replaced.
4. An extended vacuum test was performed on the closed housing to verify the seal replacement had worked. -11Hg was held overnight and therefore the test passed/
5. Pre shipping QA check list to be prepared which includes checking all fasteners and blanks for correct torque.
6. The vacuum test port was blanked as a precaution.

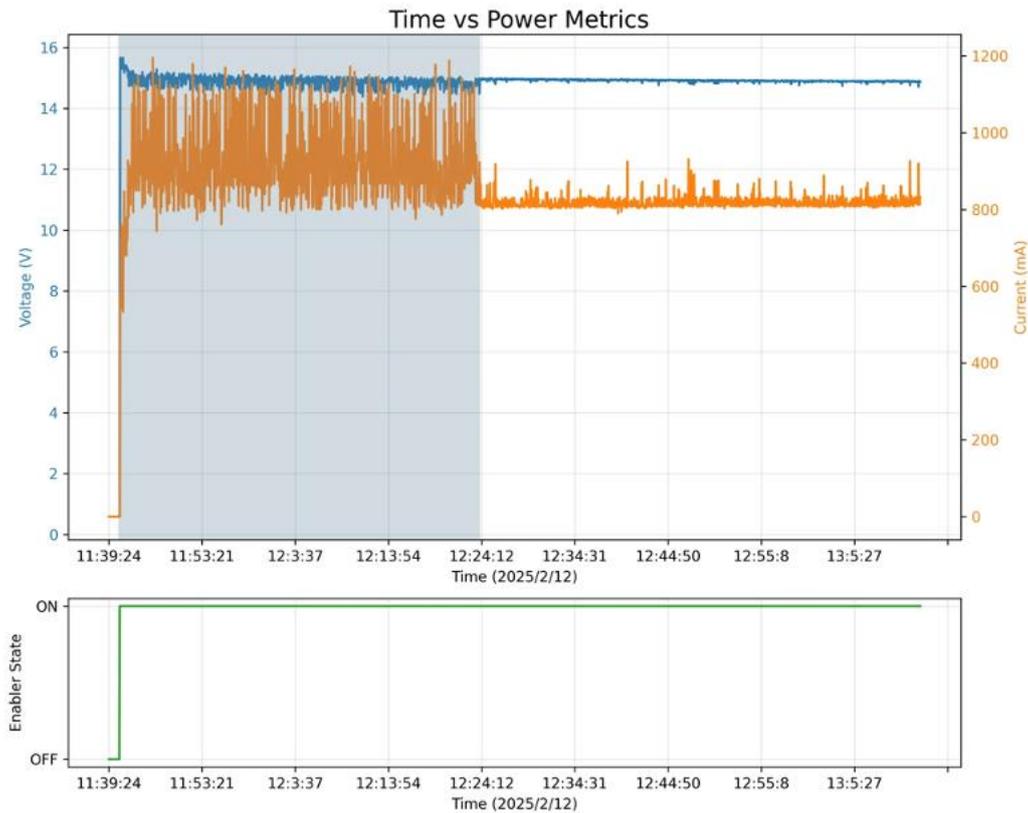
Figure 6 Haul 1 Time vs Power Metrics.

It was confirmed that both strobes were flashing before deployment from the vessel deck and the gate was set to default release position. Upon recovery, the strobes were not flashing and only 4 fish were caught, which indicated there might be a miss fired causing gate rotation into catch position. A review of the go-pro footage revealed the gate rotation did not rotate throughout this haul.

From the recorded sensory data, the first haul lasted one hour and thirty-three minutes, which aligns with the timestamps in the haul data during trials. This confirms that power from the latch battery was correctly supplied to the components inside the camera housing and that the sensors were operational. However, data logged by the AI system indicates that the camera system, strobe, and AI detection, were functional for only forty minutes. This finding is further supported by the power metrics highlighted in the shaded area of the figure 6. During this period, four fish were detected—one was too small, while the other three met the catch criteria, triggering the gate.

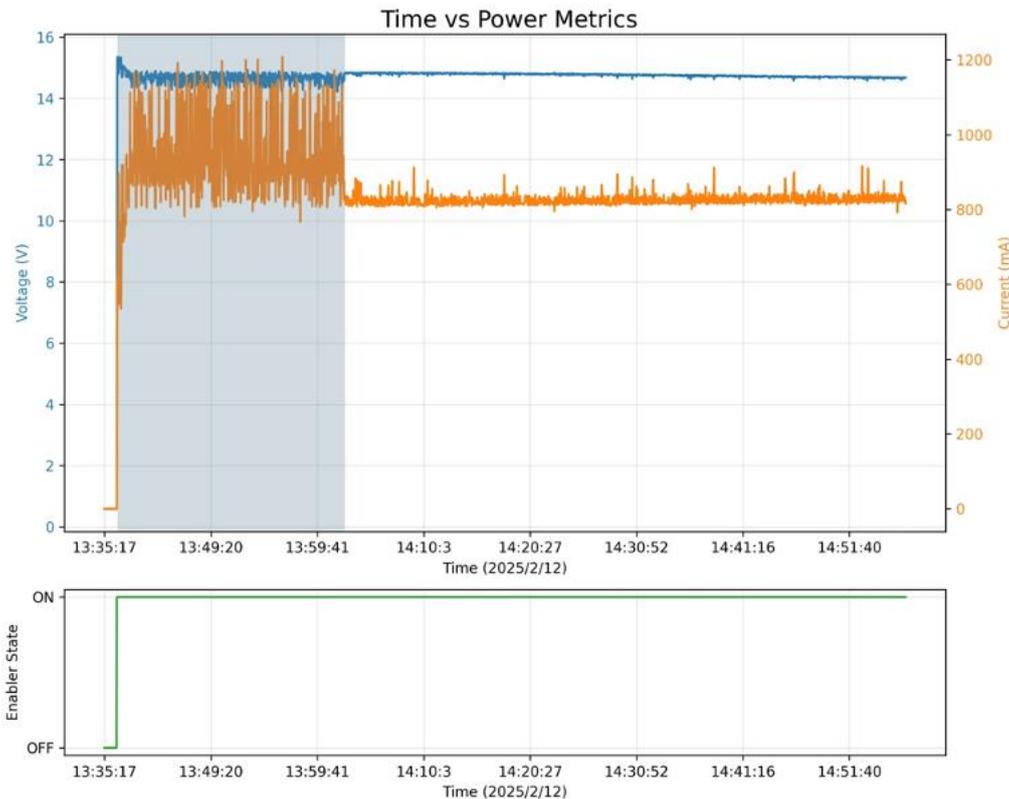
Figure 7 Haul 2 Time vs Power Metrics.

On this occasion the system required several reboots before it completed the startup cycle. Before deployment the gate was set to default release position and upon recovery, the strobes were found to not be flashing and only five fish were caught. The go-pro footage revealed no gate rotation throughout.

From the recorded sensory data, the second haul lasted one hour and twenty minutes, and again this aligns to the timing in the haul data during trials, confirming that power from the latch battery was correctly supplied to the components and that the sensors were operational. However, data logged by the AI system indicates that the camera system, strobe, and AI detection, were functional for only twenty-one minutes. This is further supported by the power metrics highlighted in the shaded area of figure 7. During this period, two fish were detected, both of which met the catch criteria, triggering the gate.

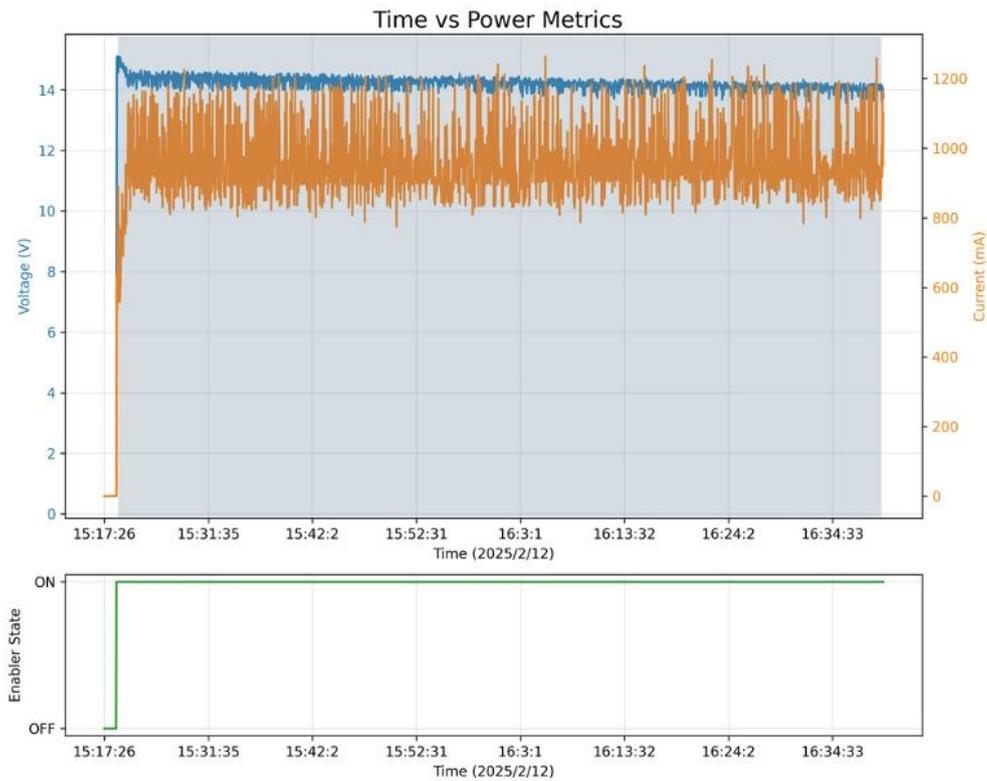
Figure 8 Haul 3 Time vs Power Metrics.

As with haul 2, the system required several reboots to become fully operational. The gate was set to default catch position before deployment and upon recovery, there was only one strobe flashing. There was a mixed catch as the latch was set to catch position. The go-pro footage revealed no gate rotation throughout.

From the recorded sensory data, the third haul lasted one hour and twenty-two minutes, aligning with the timing in the haul data during trials. The data logged by the AI system indicates that the camera system, strobe, and AI detection, were functional for one hour and seventeen minutes. This is the first time the entire system was up running for the entire haul without disruption as is shown in figure 8, although only one strobe was working upon recovery. There were 1764 images collected on this haul. During haul 3, six fishes were detected. four was too small, one was too large and only one met the catch criteria, triggering the gate.

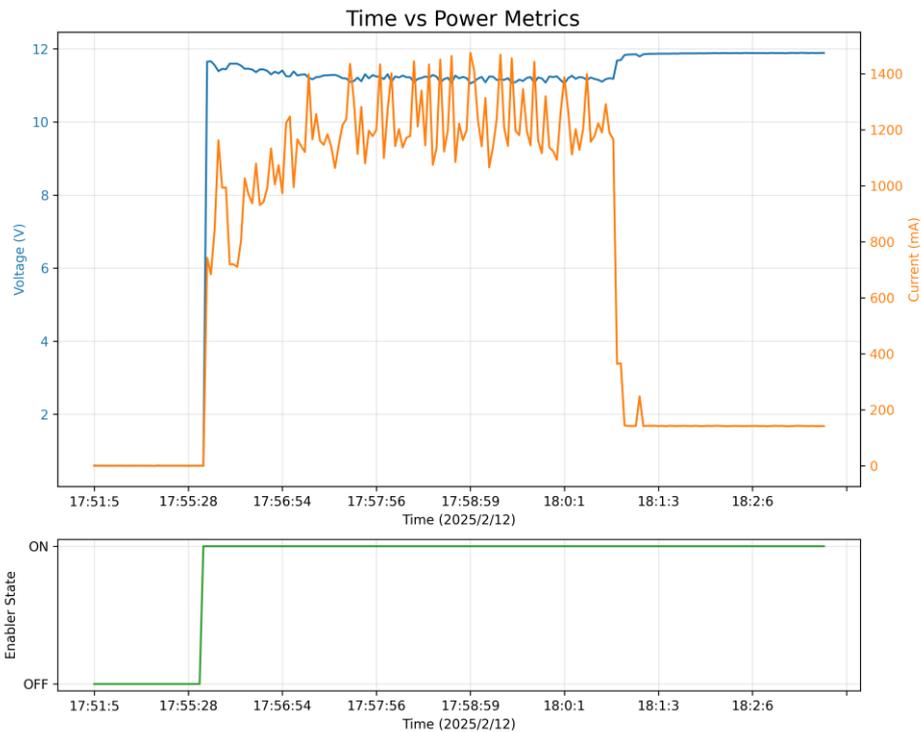
5.7 Back at Shetland Lab on 13th February at 18:13

Reviewing the sensor data (figure 9) 17:50:52, we believe this was the time when the team attempted to access the camera system after the sea trials. The current draw dropped to 180mA after five minutes, which is abnormally low and consistent with what we observed when the kit was tested with a bench power supply during postmortem. Based on the water droplets observed inside the camera dome and the corrosion on the carrier board, we suspect that water ingress was the cause of this and prior issues when the system struggled to boot up. The water appeared to have accumulated around the M.2 E-Key, and when the system was powered on, it caused a short circuit on the board, leading to a failure of booting up.

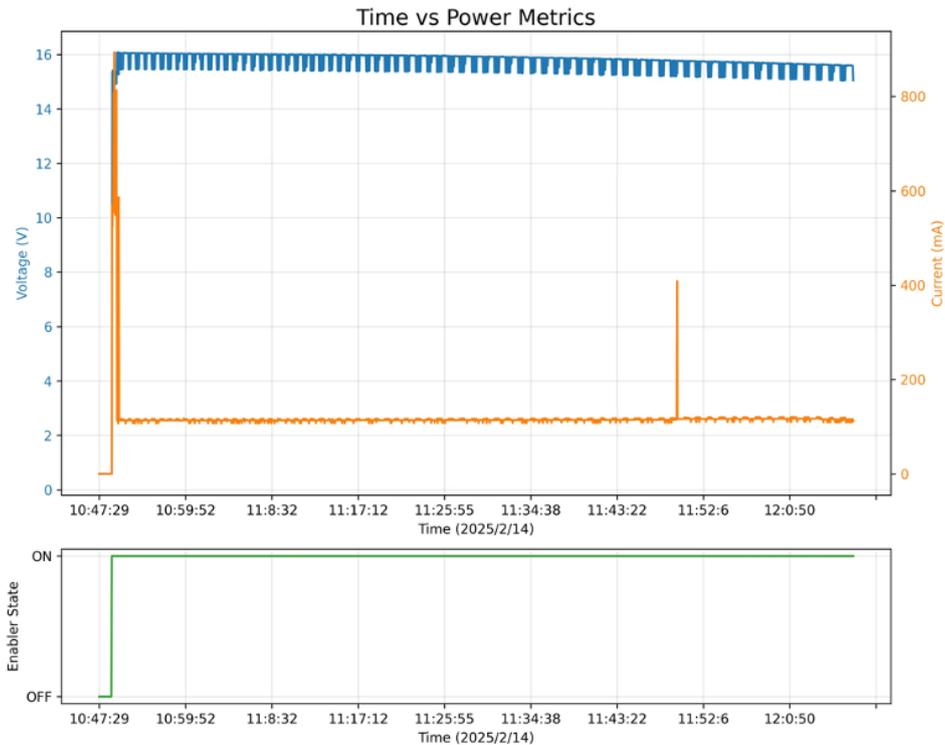
Figure 10 Haul 4 Time vs Power Metrics.

Although the strobes were not reliably working, as there was still vessel time available it was decided that a separate torch should be attached to the stereo camera frame to illuminate the camera frame in case strobes were not working. The system is deployed when with the green LED flashing indicating the system had power. Upon recovery, the strobes were not flashing the latch was seen to continuously disengaged and engaged. A review of the GoPro footage show that the gate is rotating between catch and release position.

The current dropped significantly around 10:50 on 14/02/2025, which we believe marks the moment water began seeping into the latch bottle, causing the system to behave unpredictably. The repeated latch activity observed on the GoPro footage was not triggered by the camera system but in fact was due to shorts within the latch bottle electronics.

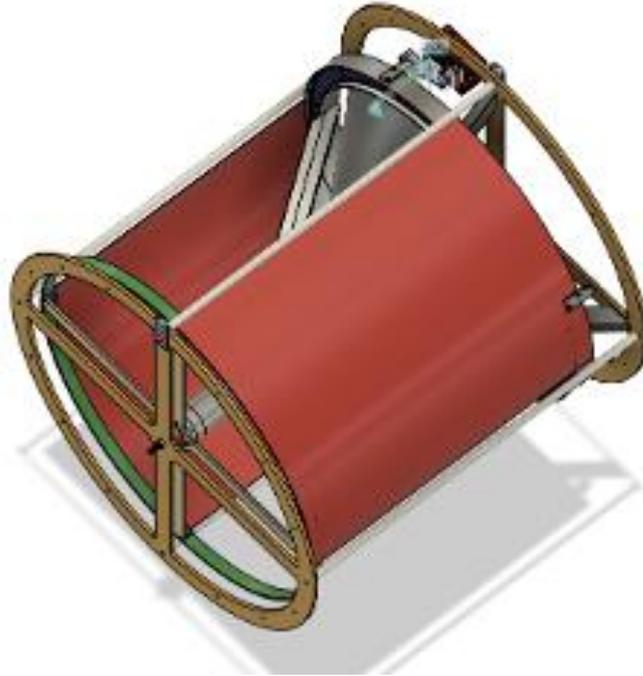
Figure 16: Revised gate design (Gate V2)

The original gate (gate VI) had too much play in the bushing it was rotating on, which we swapped out for marine bearing for a smoother spin in Phase 5. The centre column was made up of multiple parts bolted down the centre to hold in place. This had to be finely adjusted to hold things tight enough to not loosen off but not too tight it restricts the ease of the gate spinning. This has been addressed in the new design, shown in figure 16

- Redesign the centre column, making it more rigid – 40mm tube. This in turn will lead to the increase of size of the central spinning cone assembly.
- Increased size of marine bearings – from 20mm to 40mm, this will increase the rigidity and increase lifespan of the gate.
- Added holes in end plates to make lashing gate to trawl net easier.
- Addressed the buoyancy issue by adding polyurethane expanding foam into the dead zones behind the green plastic panels.
- Relocated the latch bottle
- New lifting points & shackles onto the gate to ease moving it around and deploying at sea have been added.
- Relocated the latch bottle for easier access to remove batteries for charging. This also made adding buoyancy foam easier, shown in figure 17.
