SMARTRAWL Phase 6- technical summary

FIS046

Smartrawl Phase 6 Report

March 2025

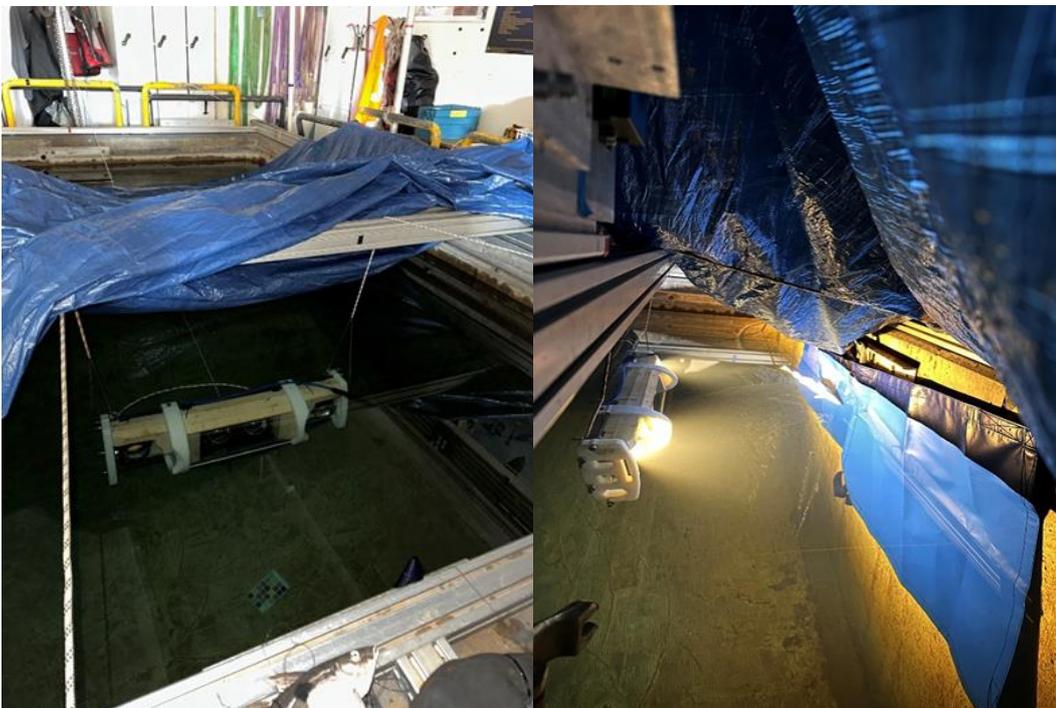
Figure 11 – Tank testing set up with a dark blue tarpaulin positioned opposite the stereo camera to simulate background tarpaulin in trawl extension. Model fish positioned opposite camera field of view.

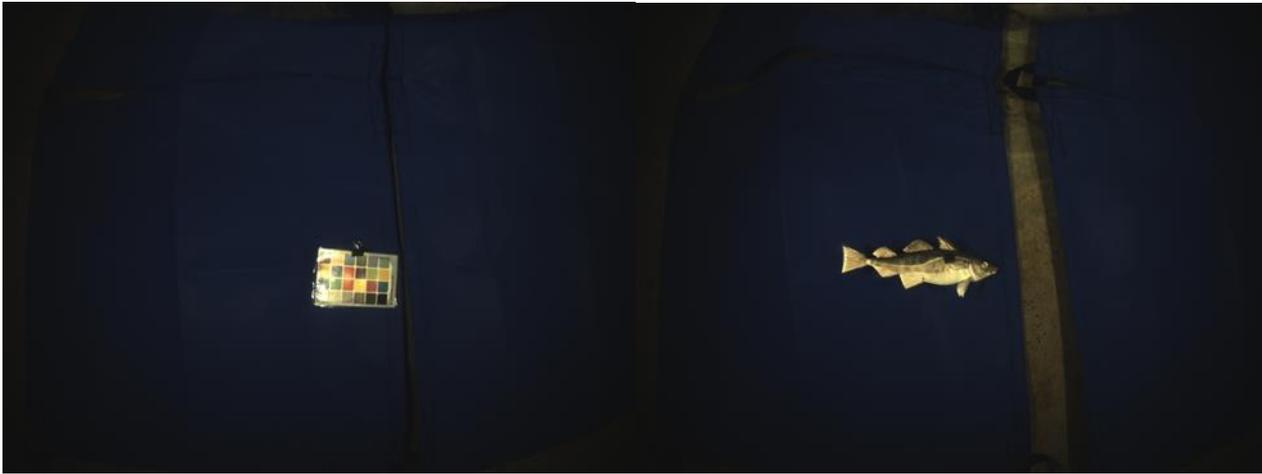
Figure 14 – Image from left camera of colour card used to check camera parameters and of a model haddock fish.

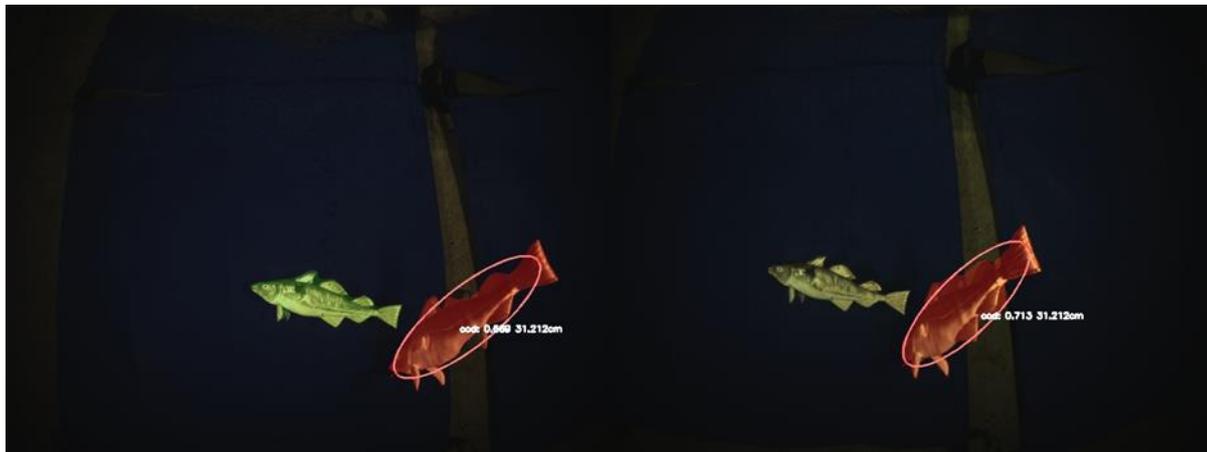
In order to see the processed visualisation from the AI, the vis toggle was turned on. This will not be turned on during at sea testing as this double saves images and increased processing time. However, for tank trials this allowed to clearly see detection and if species classification and sizing was correct. Below the cod is identified but the sizing is incorrect as the model cod is 42cm. And the haddock was not detected.

Figure 15 – Paired image of annotated fish, both haddock and cod are in frame – AI model has correctly identified cod, of a high confidence and length of 31cm.
